Redevelopment Study and Preliminary Investigation Report

Block 15, Lot 2 and Block 53, Lot 1

Prepared: January 16, 2023

Borough of Keansburg Monmouth County, New Jersey

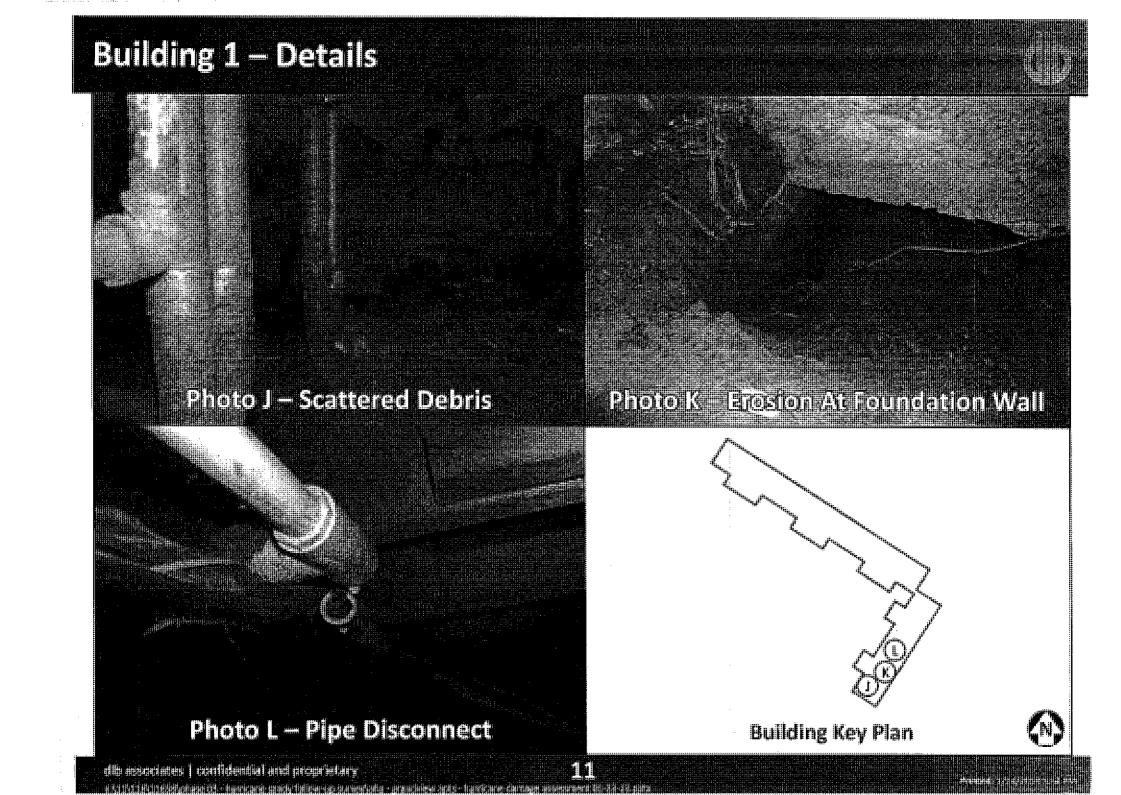
The ground was heavily saturated with water, and the East foundation walls were still showing signs of water penetration. This may inhibit the reliability of ground-supported piping.

There was a heavy musty smell and an excess of moisture and standing water, particularly along the foundation walls. This may contribute to mold growth in the warmer weather.

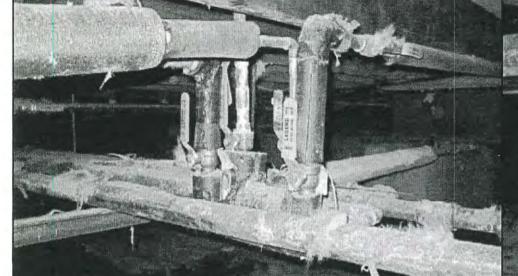
Photo G – Evidence Of Pipe Corrosion

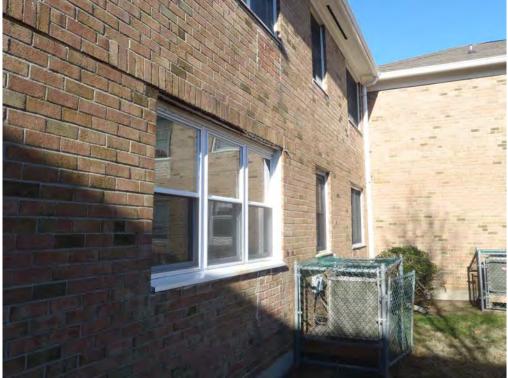
Photo A: Continuous horizontal crack and rusted lintel at Bldg 9 west courtyard wall

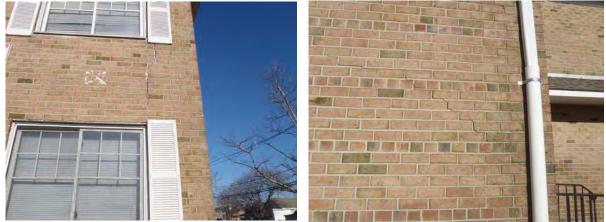
Photo B: Vertical crack at corner Bldg 9

Photo C: Step Crack Bldg 9

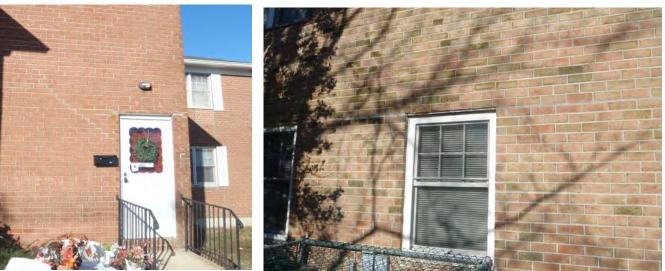
Photo G: Repaired Step Crack

Photo H: Repaired Horizontal Crack

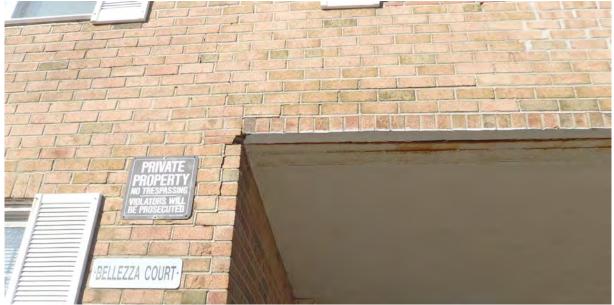
Photo J: Crushed brick and rusted lintel over carport

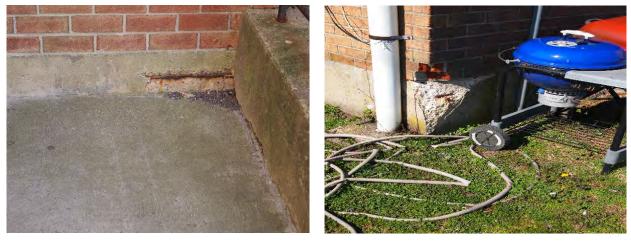
Exposed Rebars in Concrete

Broken Concrete and Bricks

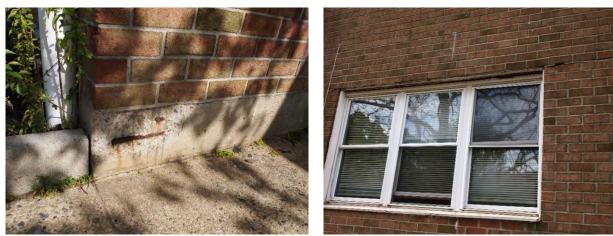
Broken Concrete and Exposed Rebar

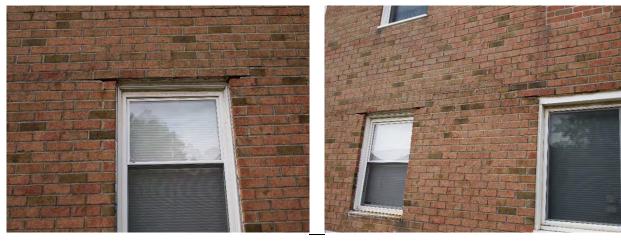
Rusted Steel Lintel

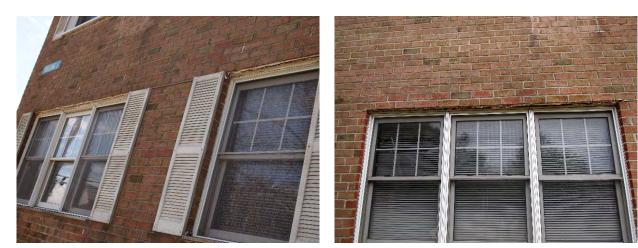
Rusted Steel Lintel

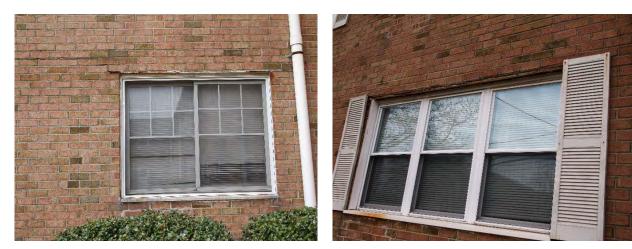
Cracked Grout
