Redevelopment Study and Preliminary Investigation Report

Block 15, Lot 2 and Block 53, Lot 1

Prepared: January 16, 2023

Borough of Keansburg Monmouth County, New Jersey

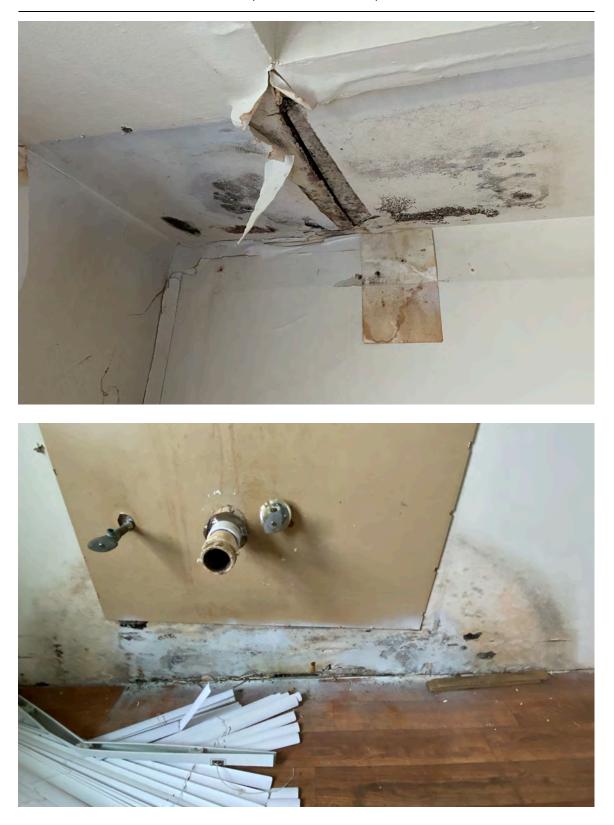
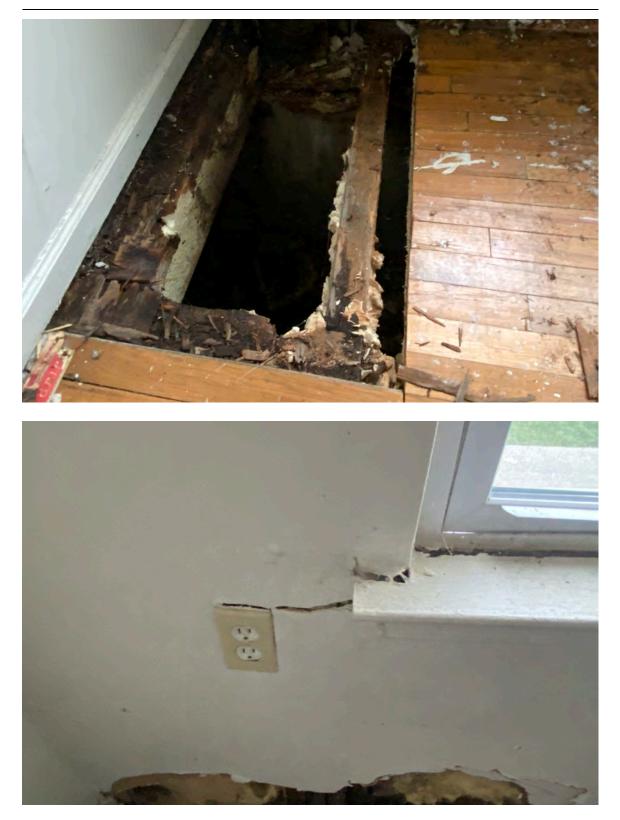
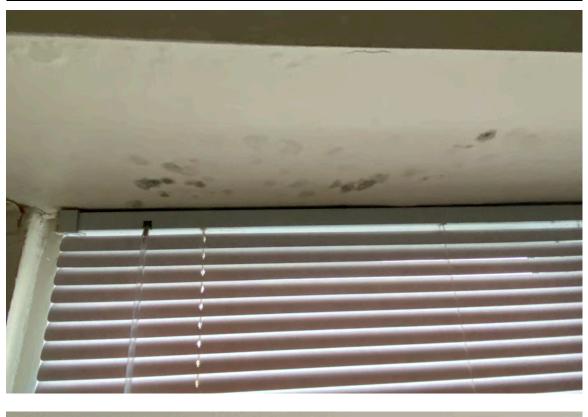
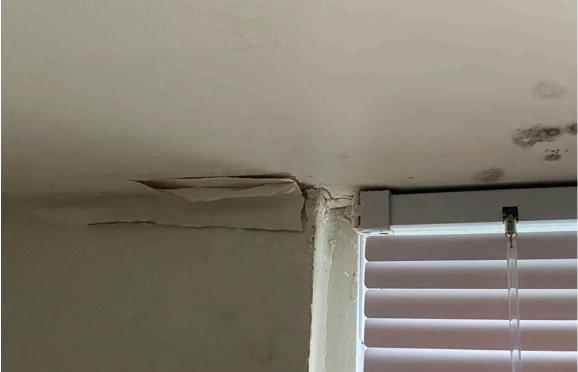
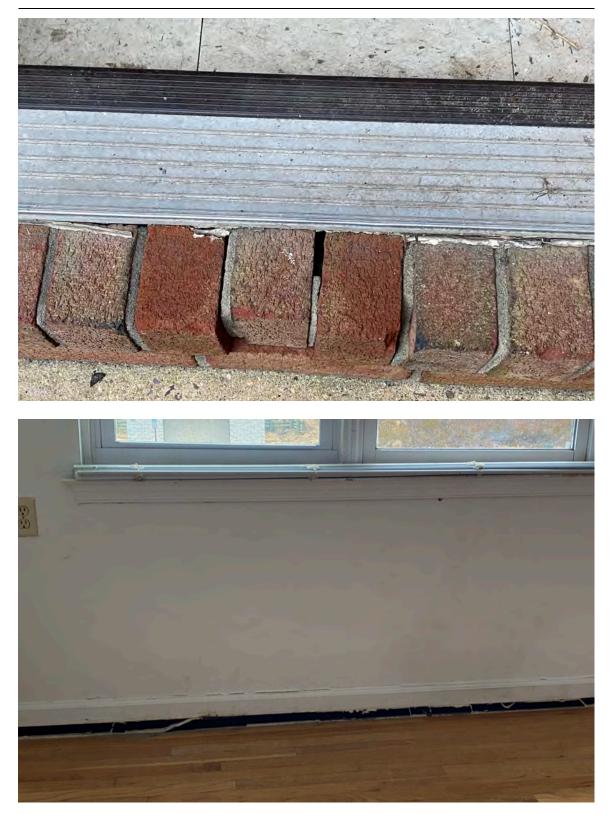
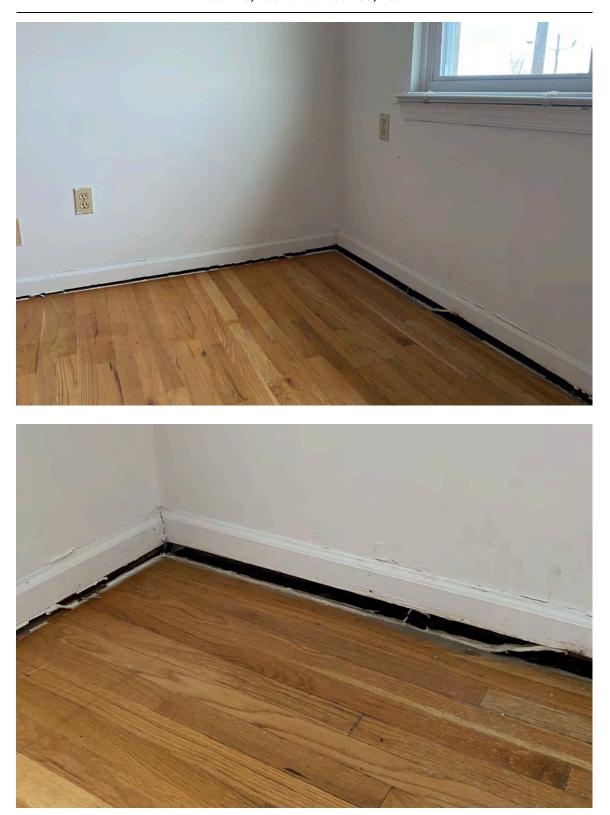
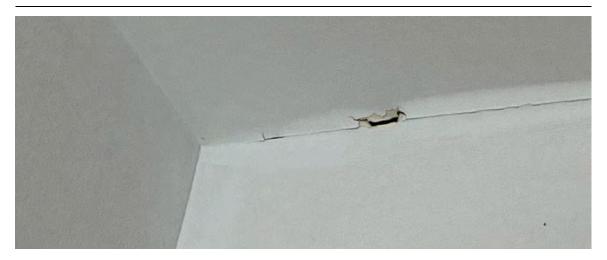
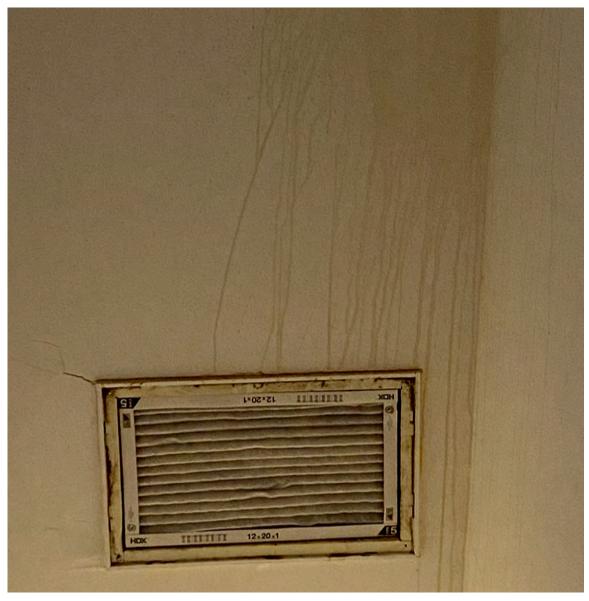
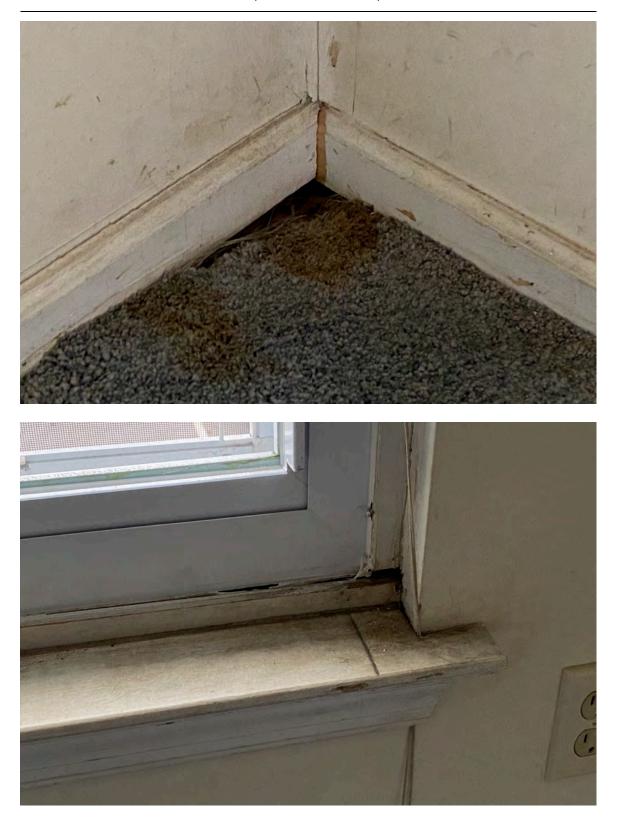
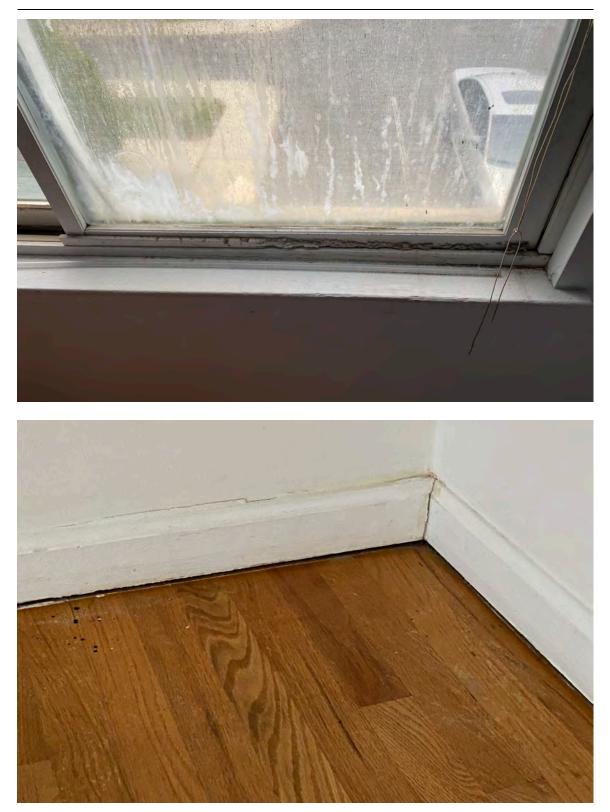
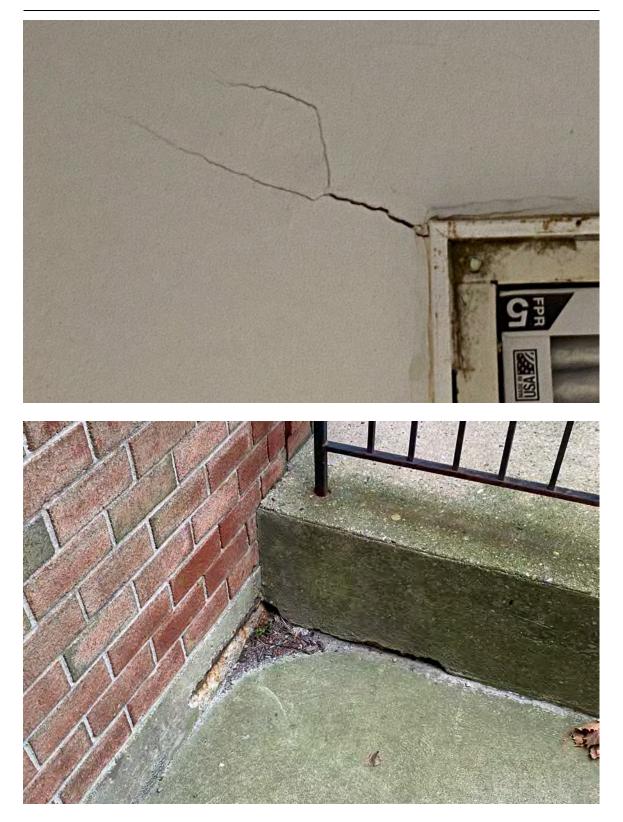
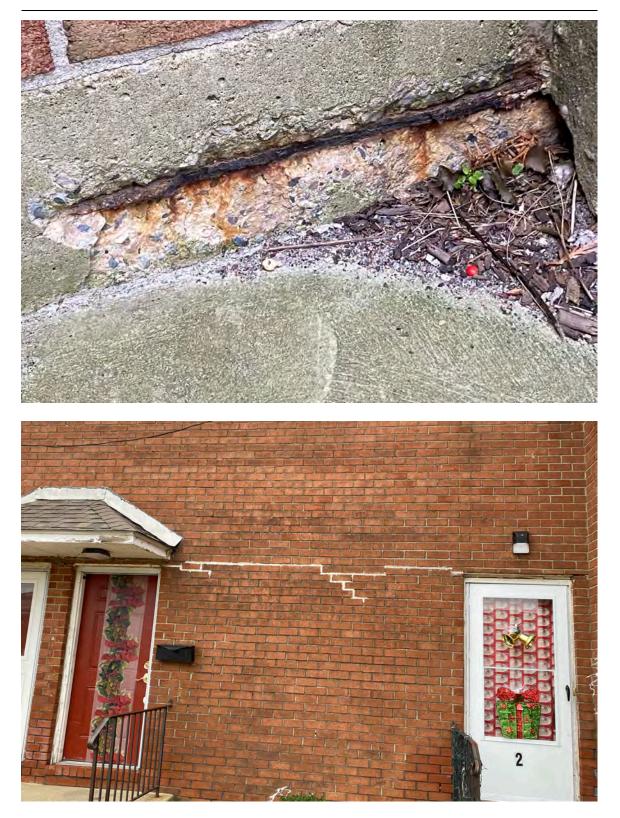
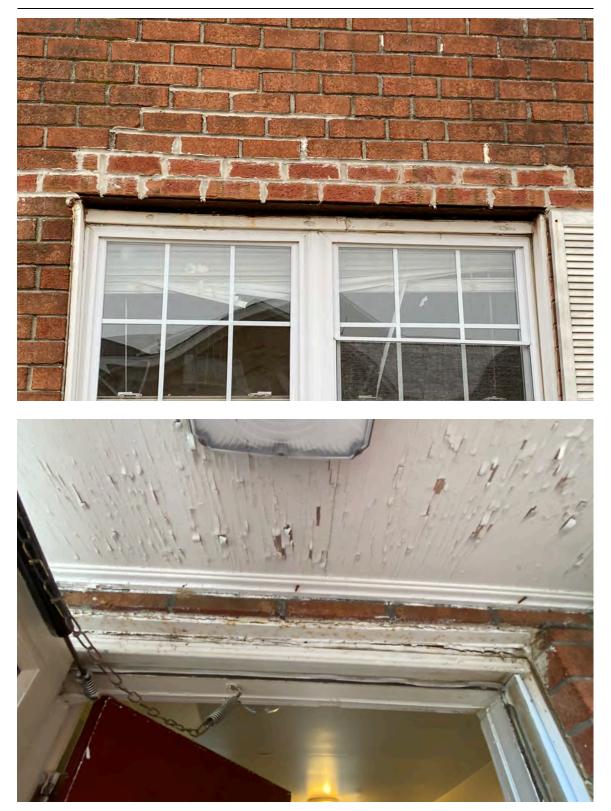
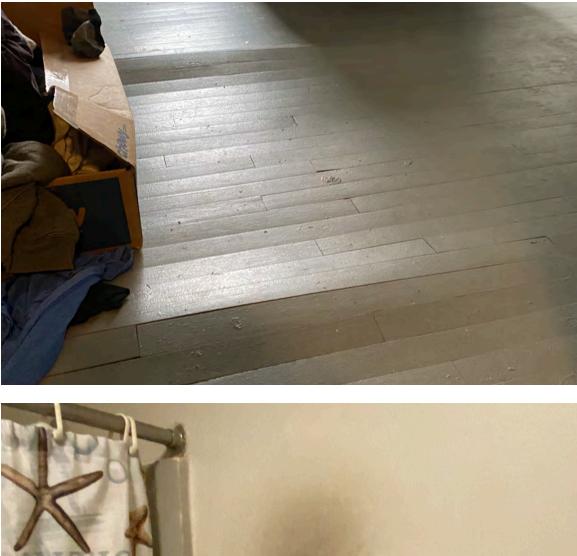
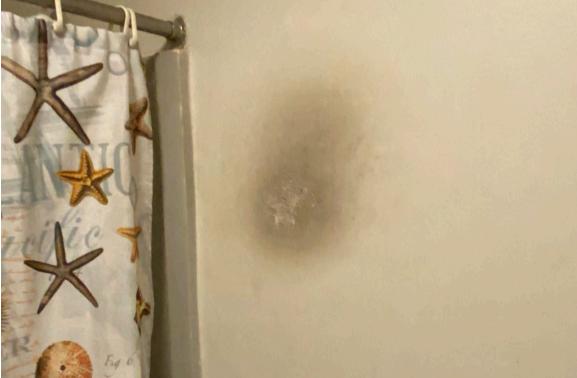
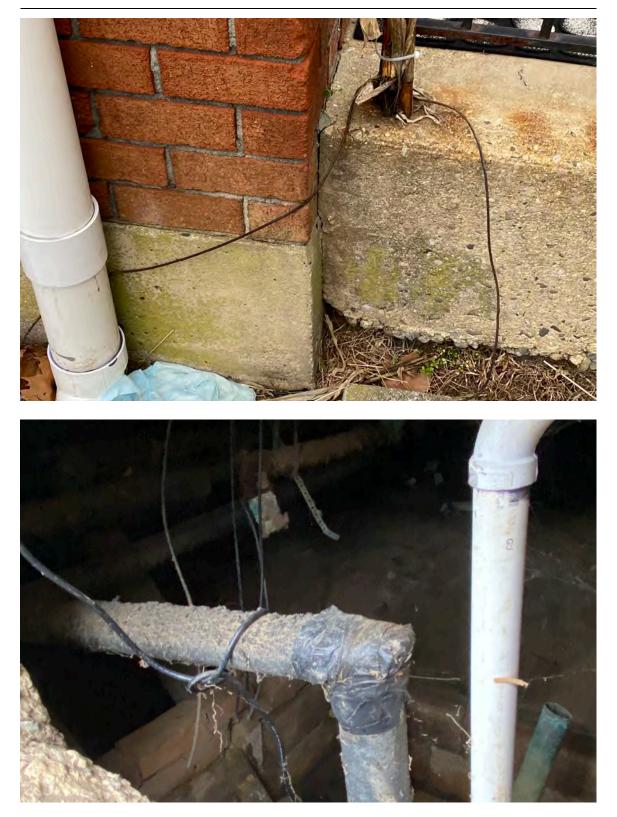
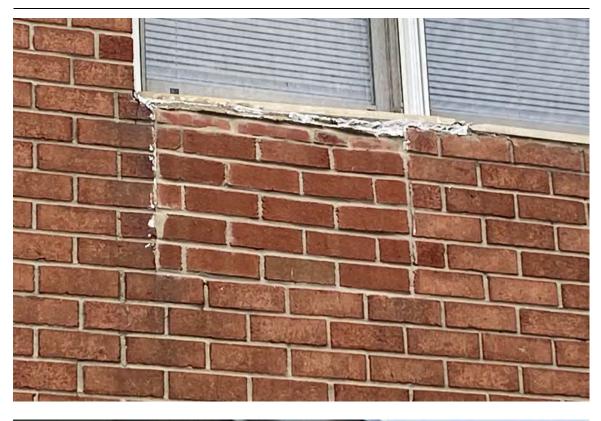
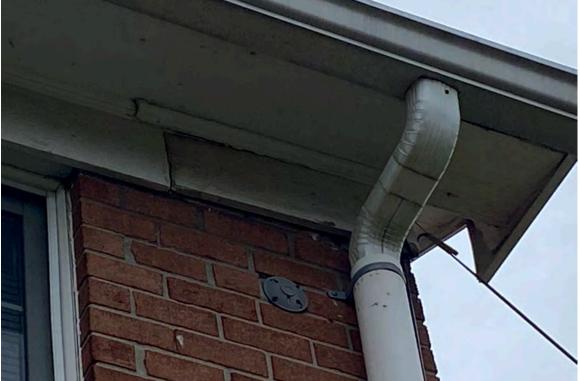
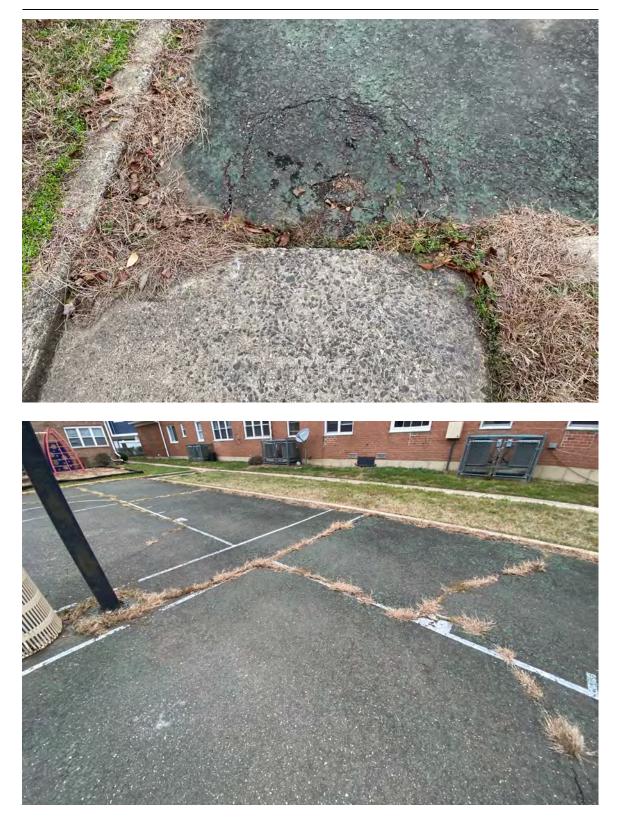
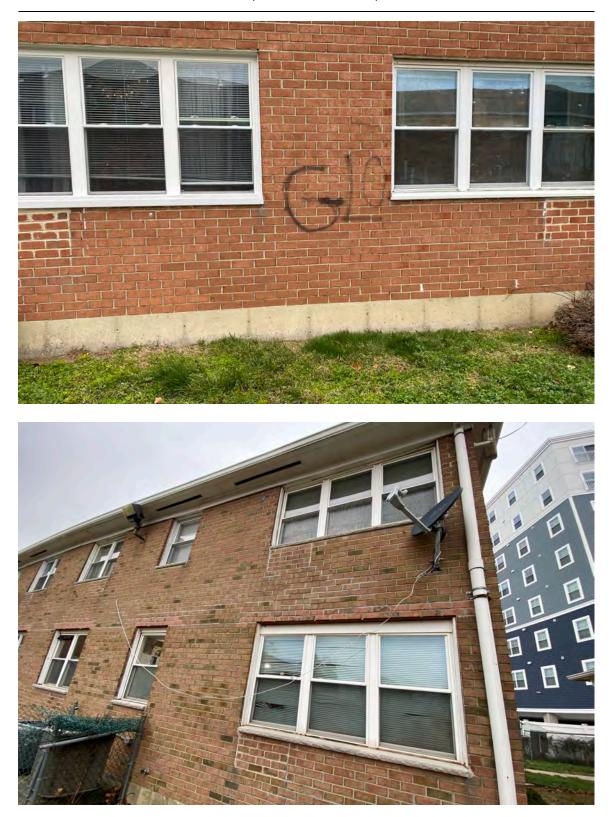
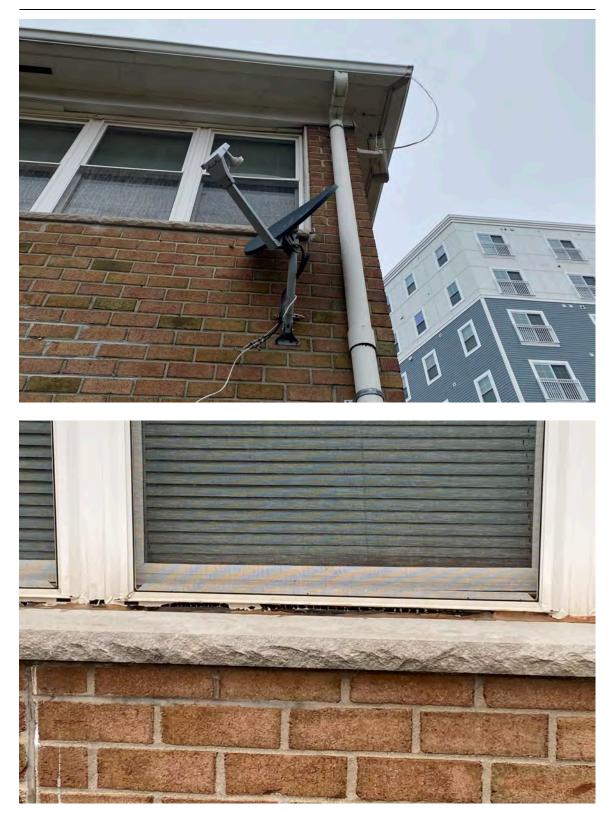
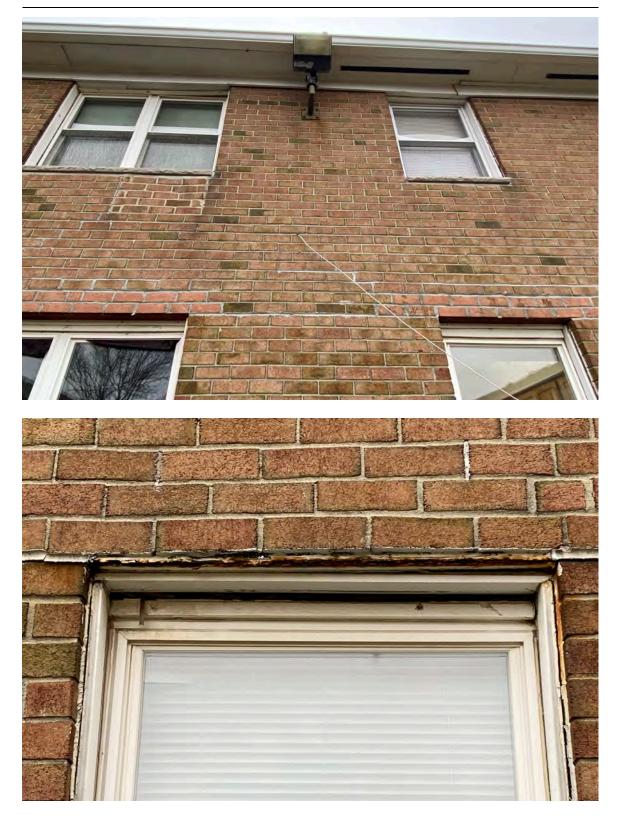
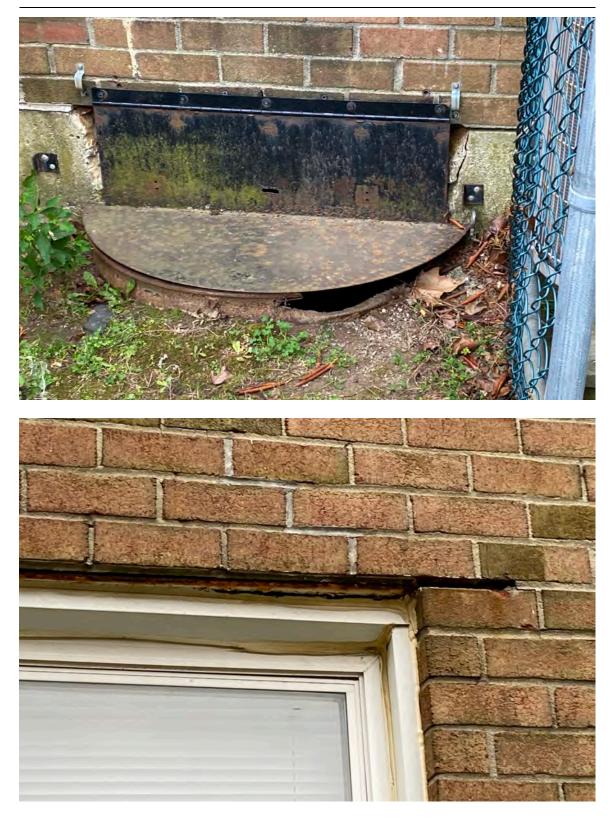
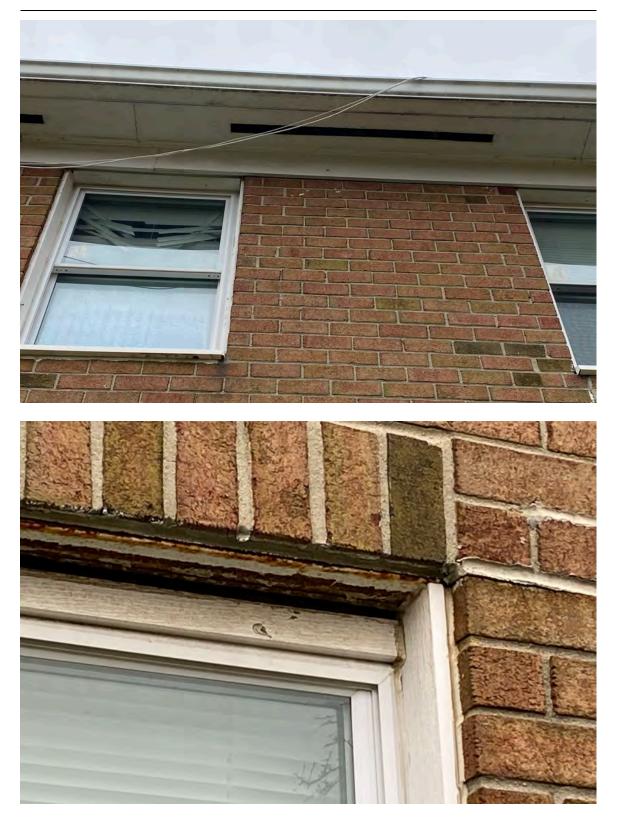
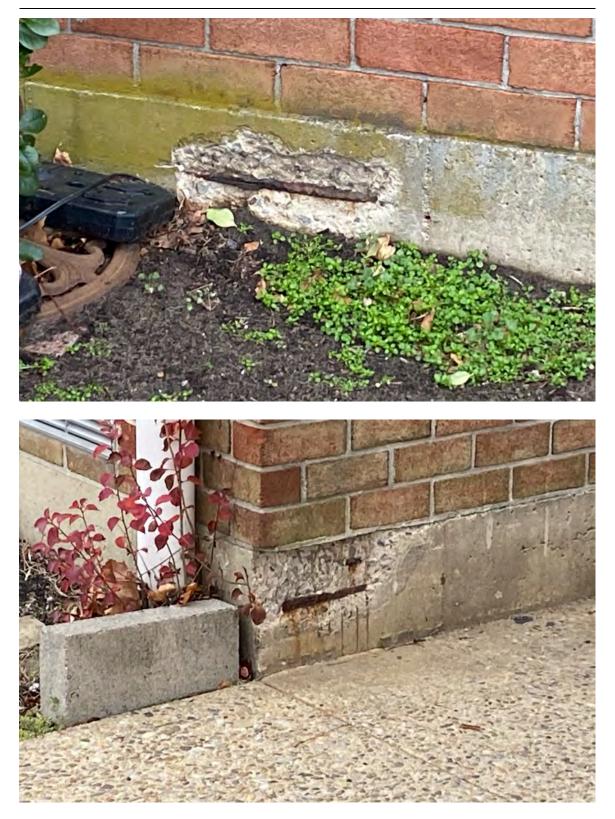
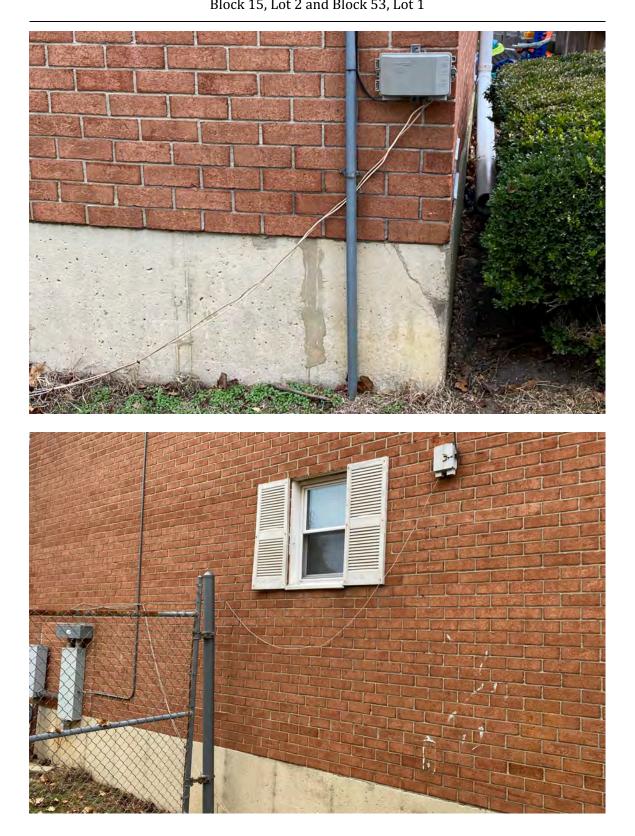
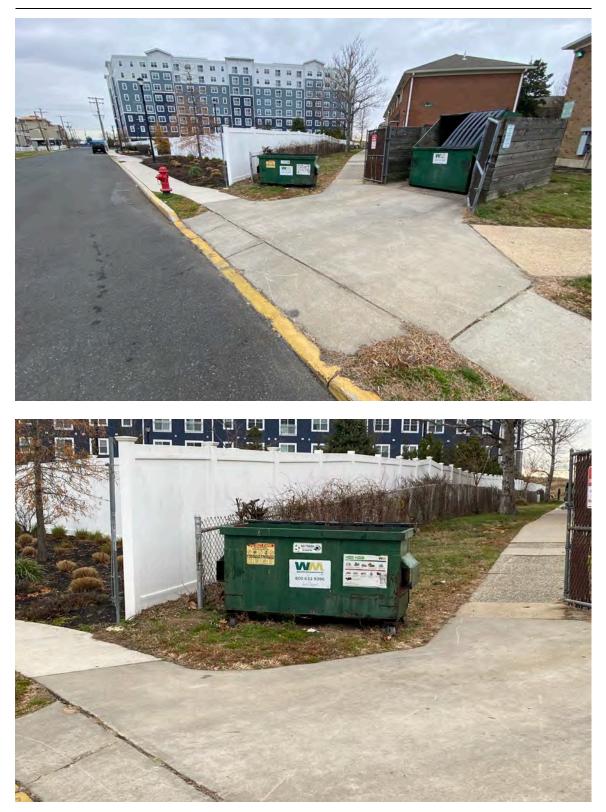
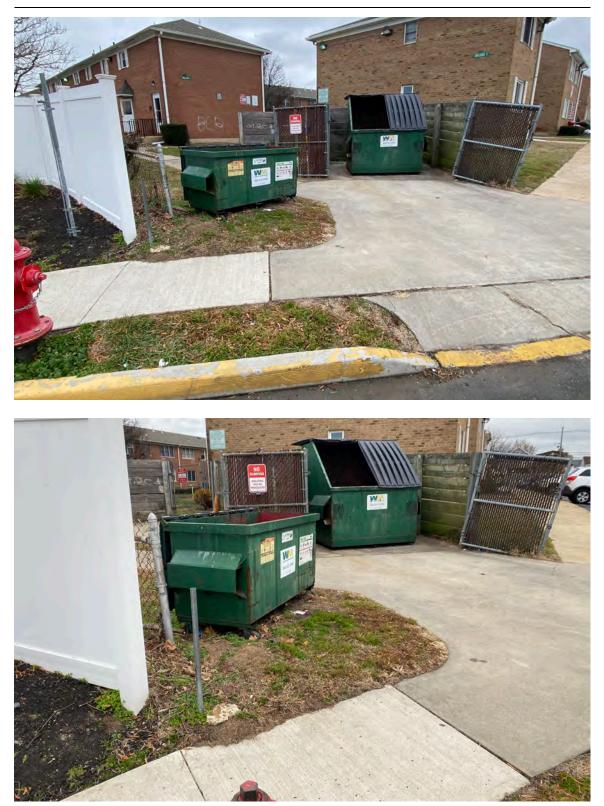
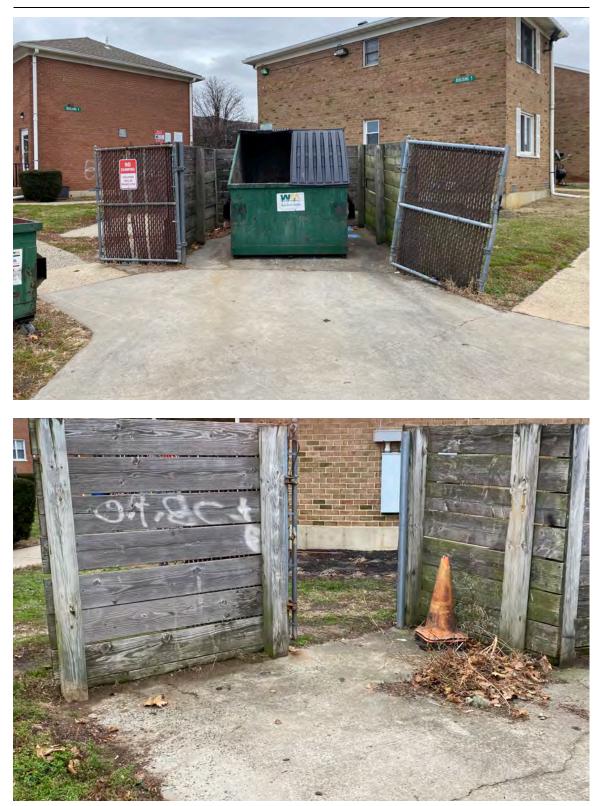
Appendix B, Part 1 — Pictures of Block 15, Lot 2

As observed by T&M Associates during a site visit conducted on December 15, 2022, the buildings on Block 15, Lot 2 were found to be in poor condition and many of the issues identified in appendices C, D, E, F and G, as referenced above, were found to persist. Indeed, as shown in the photographs of Appendix B, the buildings of Block 15, Lot 2 show: extensive step and other cracking in building façades; cracking and breakage of concrete building foundations and resulting exposure of rebar (n.b., rebar was observed to be rusted); numerous rusted and bowed lintels; portions of damaged and apparently decayed soffits; portions of partially unattached soffits; portions of partially unattached soffits; portions of precipitation; and, mispositioned windows (n.b., windows were askew). In addition, T&M Associates gained entry to interior portions of Building 1 (i.e., the northernmost building, which has frontage on Beachway Avenue) and Building 2 (i.e., the building directly to the south of Building 1), and observed: extensive signs of mold and water damage; decayed flooring; and cracking on walls and gaps between floors and walls, which indicate settlement and

subsidence consistent with appendices E, F and G. T&M Associates was also able to access the crawl space of Building 2, and observed: unsecured, substandard wiring; partially disconnected plumbing fixtures; evidence of water damage (incl., corrosion on plumbing fixtures); and generally unsanitary conditions.

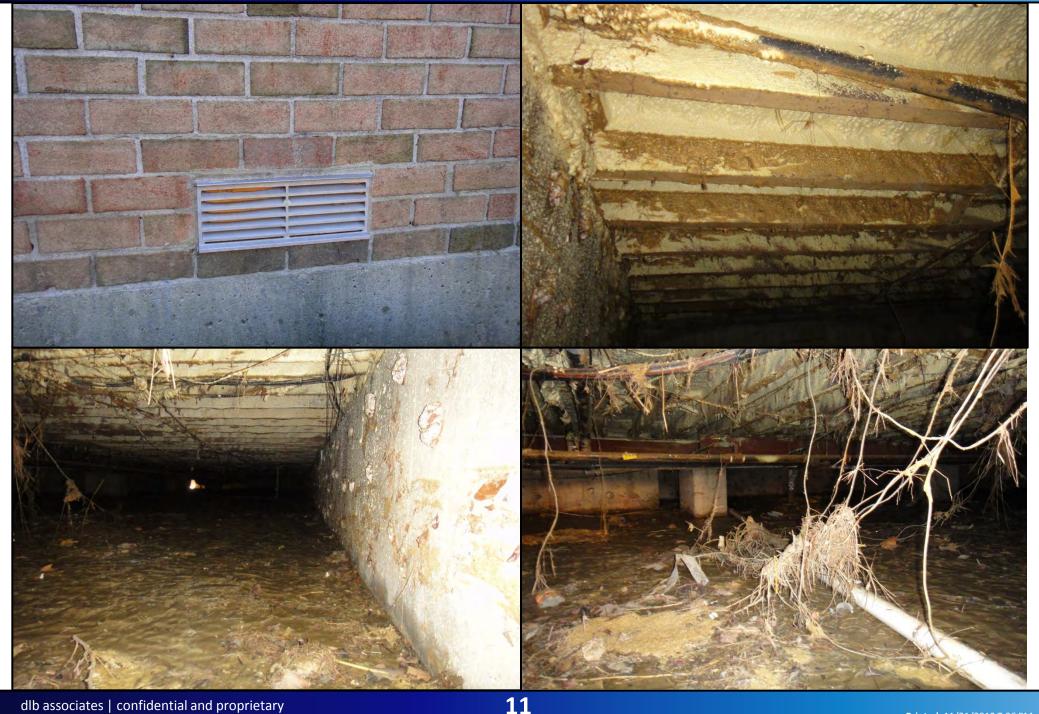
Building 4 - Mold Growth

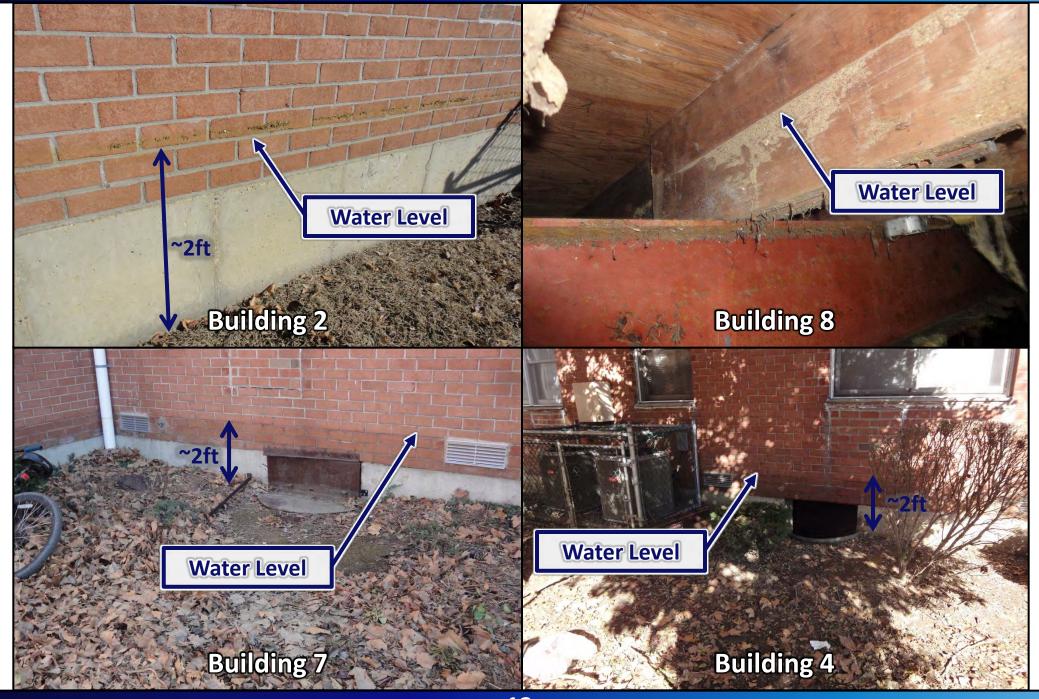
Observed Water Level Markings

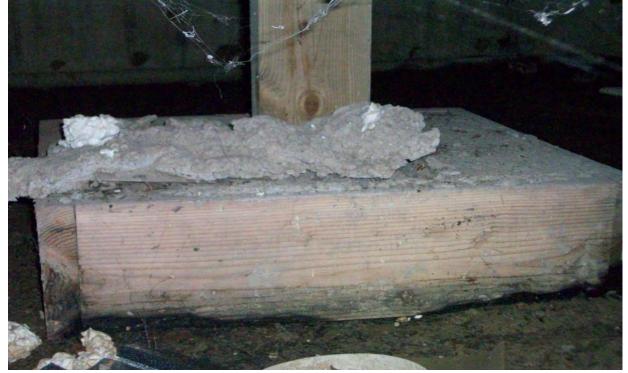
#5 – Crawlspace building 3 - mold growth on wood column

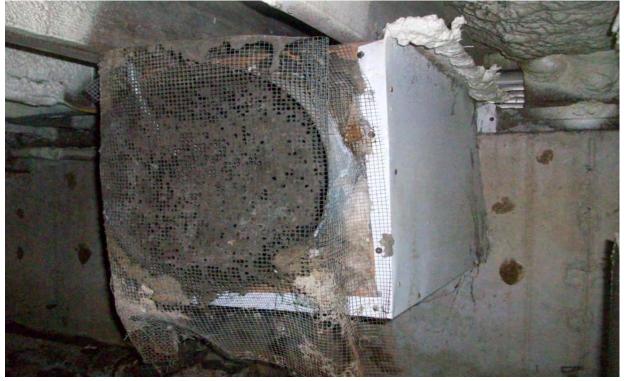
#6 - Crawlspace - Building 3 - Blockage on air vent

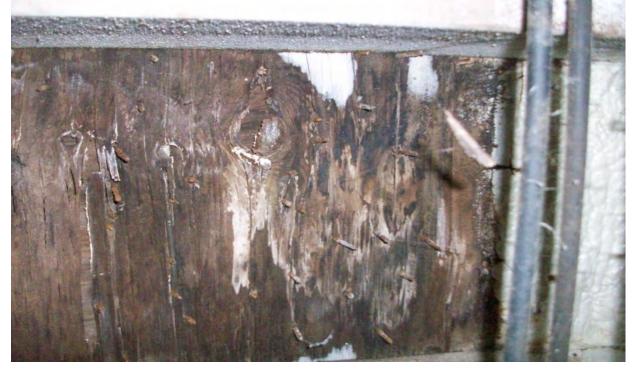
#7 – Crawlspace - Building 4 - Mold growth on wood subfloor

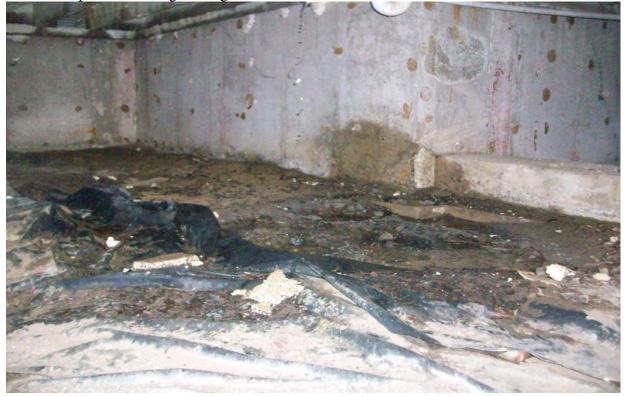
#8 - Crawlspace - Building 7 - stagnant water and wet soil/sand floor

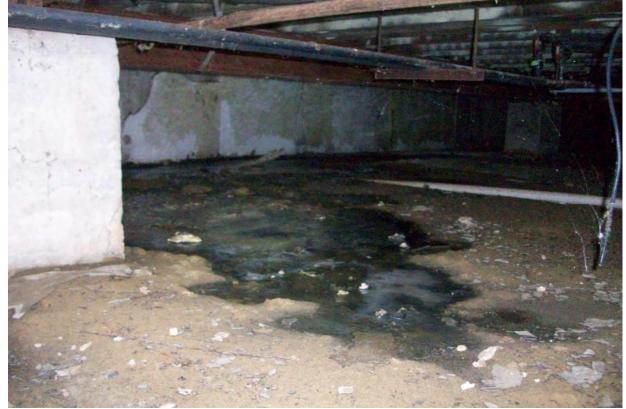
#9 – Crawlspace - Building 6 - Stagnant Water

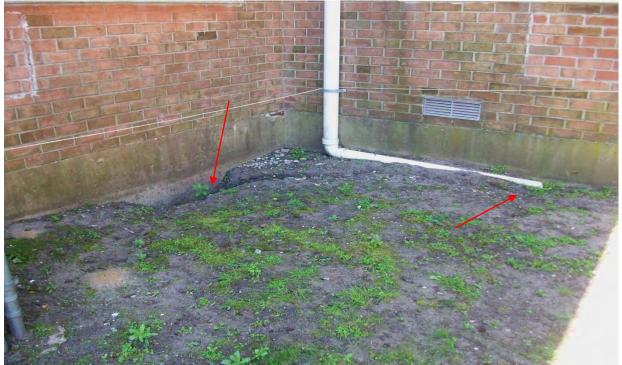
#12 - Exterior of crawl space - degrading towards the foundation and leaders emptying near fountain wall.
